**Inspection Report for  
Cochiti Community Development Corp.  
Cochiti Lake, NM**

**200KG Steel On-Grade Tank**

**Date Completed: November 10, 2016**

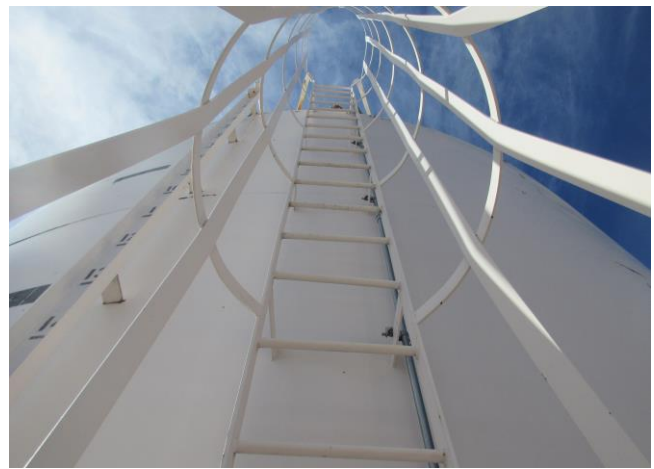
### Access Ladder Condition

Summary: The ladder was found secure, OSHA approved and in good condition with oxidation noted.

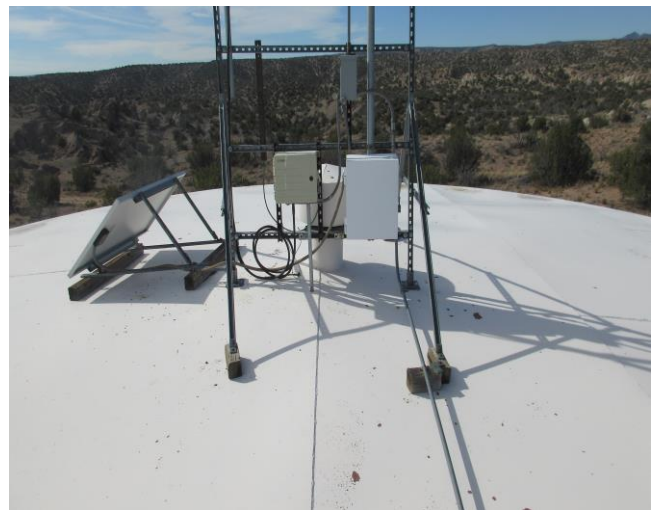
### Roof Condition

Summary: The roof was found in good condition with low spots, oxidation, minor de-lamination and 3% surface corrosion noted.

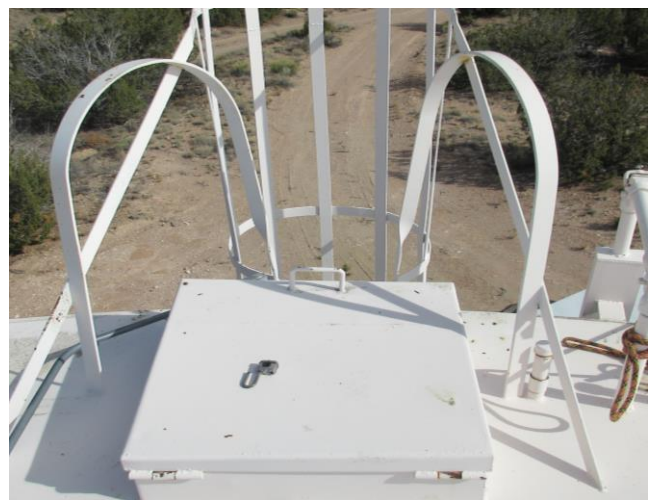
### Access Hatch Condition

Summary: The hatch was found locked with a partial gasket present and in good condition with minor de-lamination, oxidation and 5% corrosion noted. A new gasket was installed.

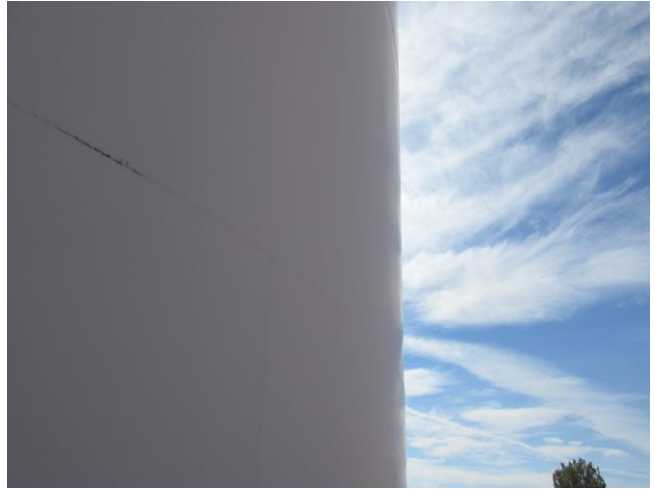
### Wall Panel Condition

Summary: The wall was found in good condition with dents and oxidation noted.

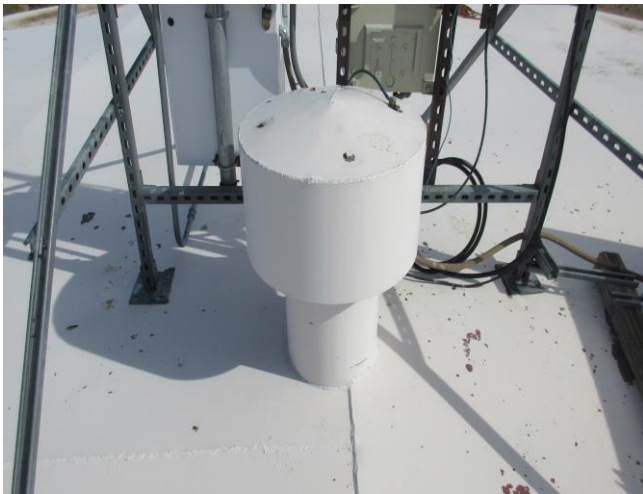
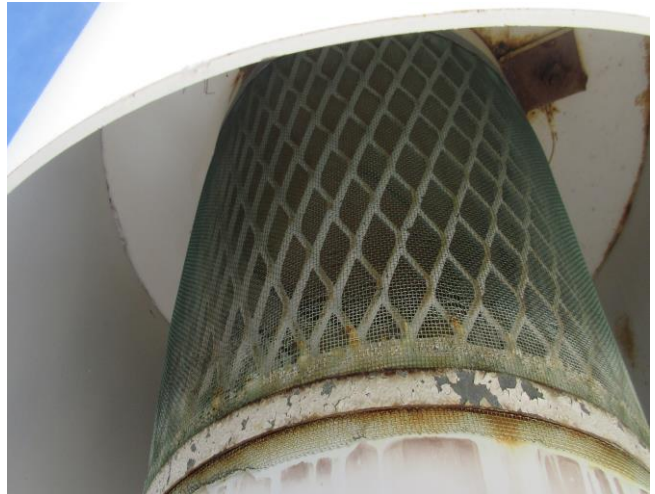
### Vent Condition

Summary: The vent was found in good condition with oxidation and 3% surface corrosion noted and a screen in place.

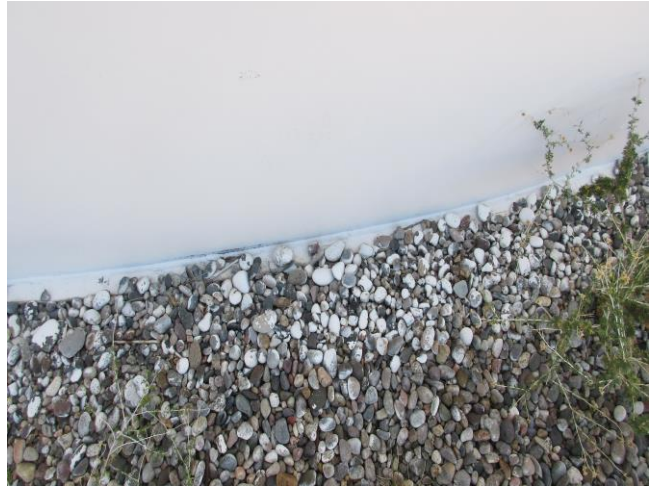
### Foundation Condition

Summary: The base of the tank was found in good condition.

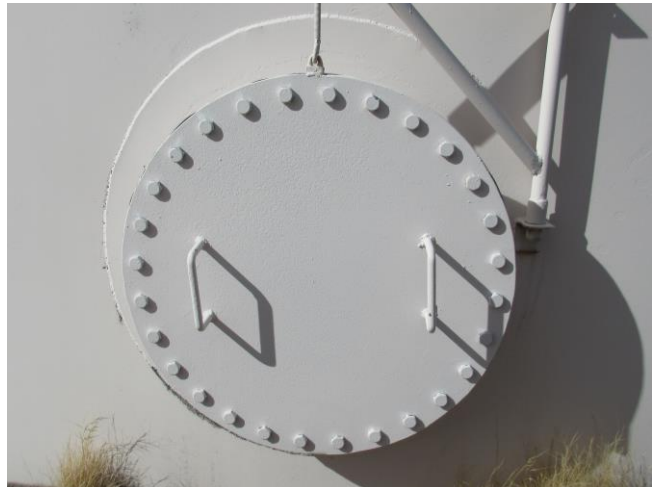
### Manway Condition

Summary: The manway was found secure and in excellent to good condition.

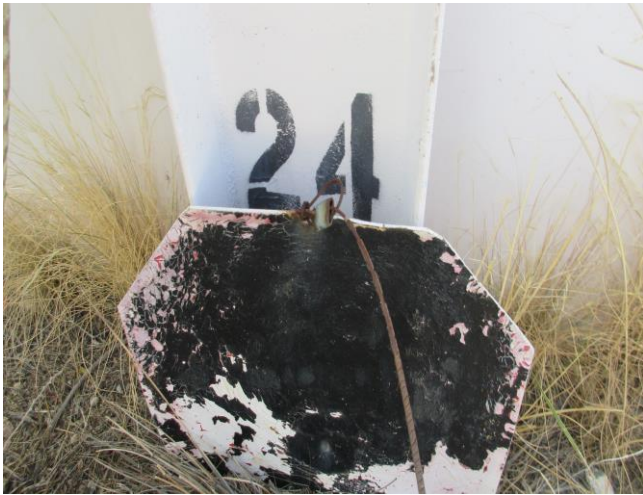
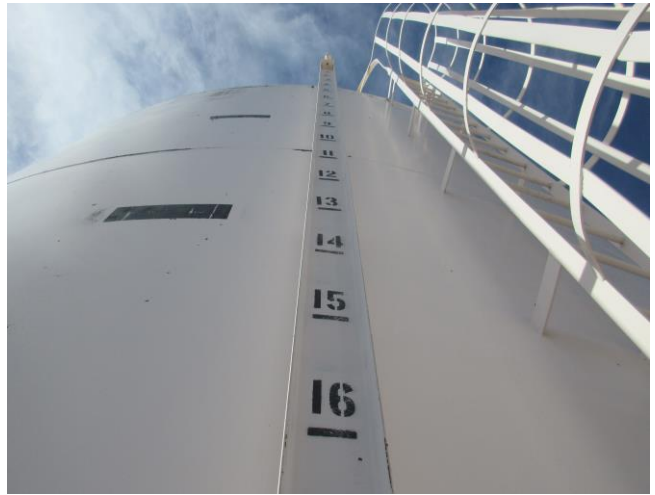
### Float Level Indicator Condition

Summary: The float level indicator was found in poor condition with a broken pulley & cable and 5% surface corrosion noted.

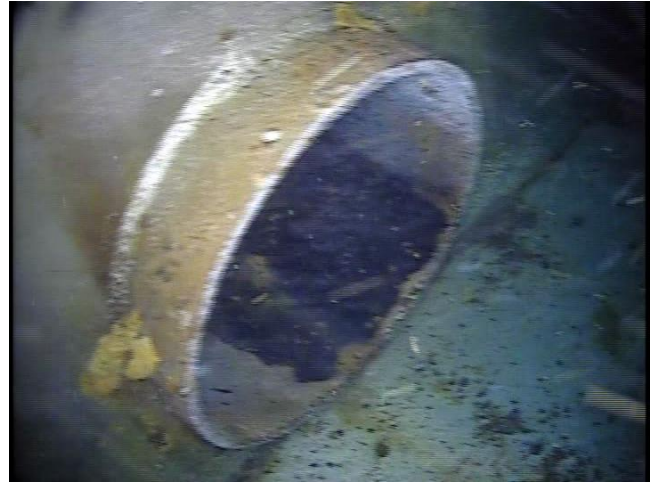
Summary: The inlet was found in good condition with 2% concentrated cell corrosion & rust noduling noted.

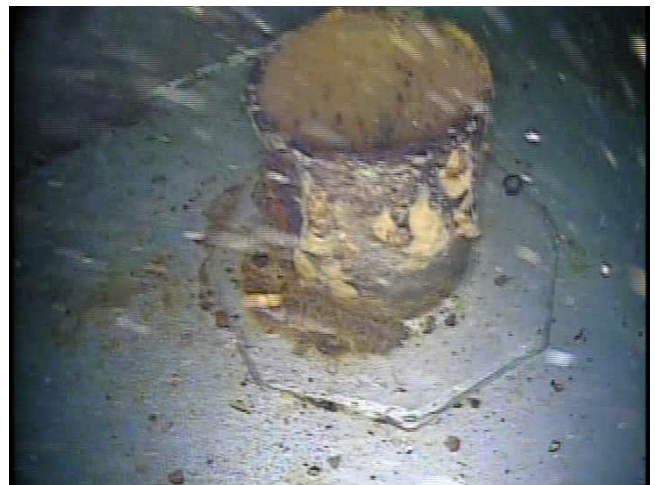
Summary: The outlet was found in good condition with rust noduling and 4% corrosion noted.

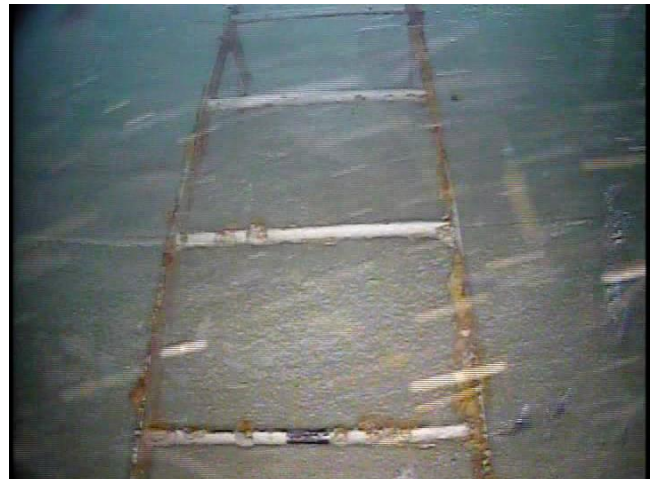
### Ladder Condition

Summary: The ladder was found secure and in good condition with less than 1% concentrated cell corrosion & rust noduling noted and oil present. It appears to be a food based hydraulic oil commonly used to lubricate water pumps in potable water system and this oil is typically not harmful.

1. Drain the tank and have it pressure washed to eliminate the oil as soon as budgets allow.
2. Schedule time for epoxy repairs to the problem areas in the tank. (Approximately 1 day)
3. Schedule time to clean and inspect every 3-5 years per AWWA recommendations.

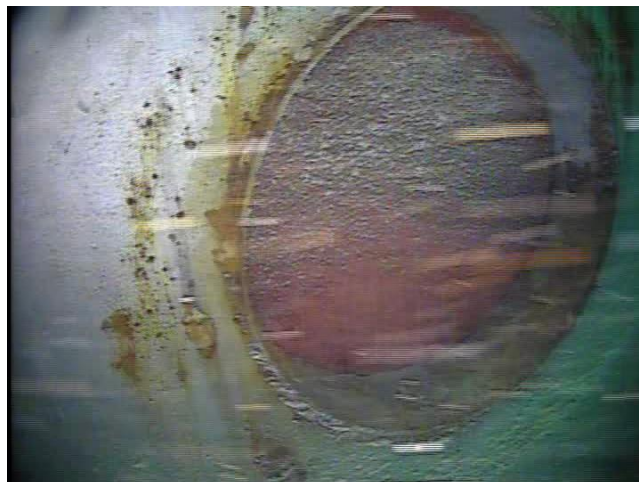
## Manway Condition

Summary: The manway was found in good condition with heavy sediment staining and less than 1% concentrated cell corrosion & rust noduling noted.

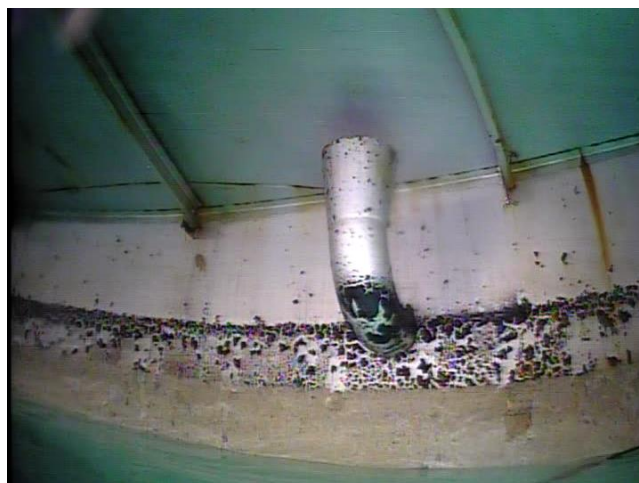
## Overflow Condition

Summary: The overflow was found in good condition with less than 1% surface corrosion noted and oil present. It appears to be a food based hydraulic oil commonly used to lubricate water pumps in potable water system and this oil is typically not harmful.

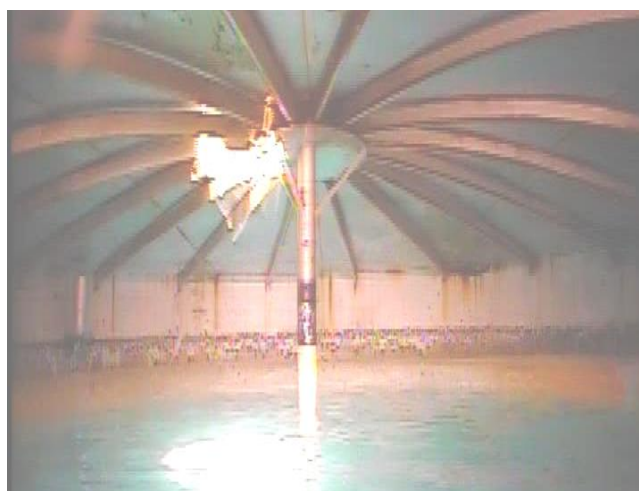
## Roof Condition

Summary: The interior roof was found in good condition with less than 1% surface corrosion noted.

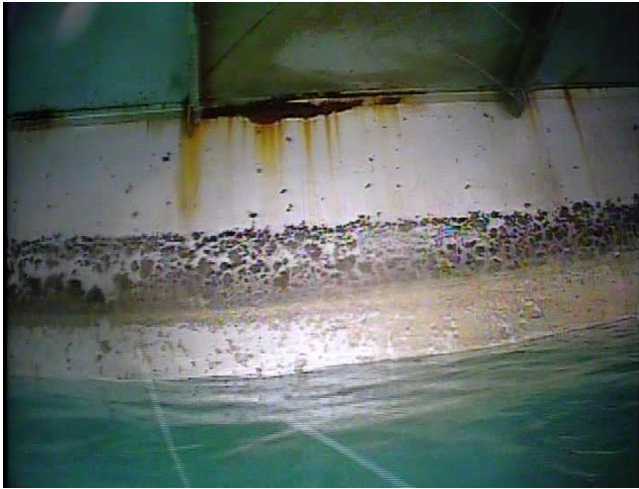
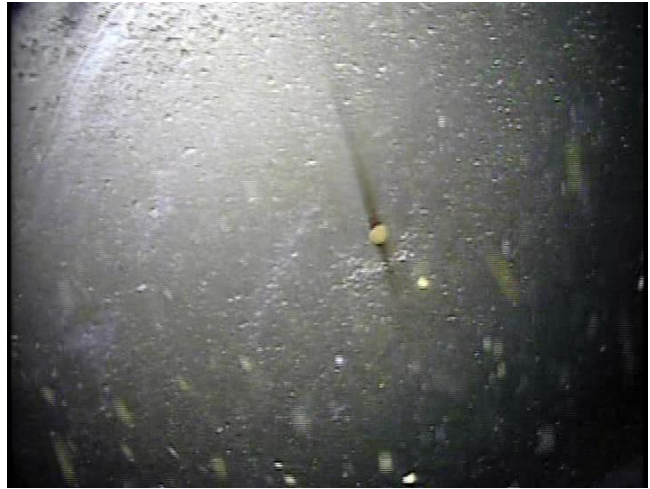
### Wall Panel Condition

Summary: The interior wall was found in good condition with less than 1% concentrated cell corrosion & rust noduling noted and oil present. It appears to be a food based hydraulic oil commonly used to lubricate water pumps in potable water system and this oil is typically not harmful.

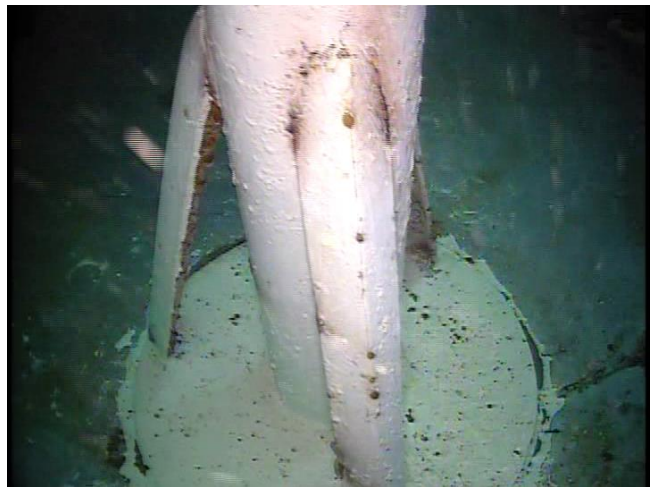
### Support Column Condition

Summary: The support column was found secure and in good condition with less than 1% concentrated cell corrosion & rust noduling noted and oil present. It appears to be a food based hydraulic oil commonly used to lubricate water pumps in potable water system and this oil is typically not harmful.

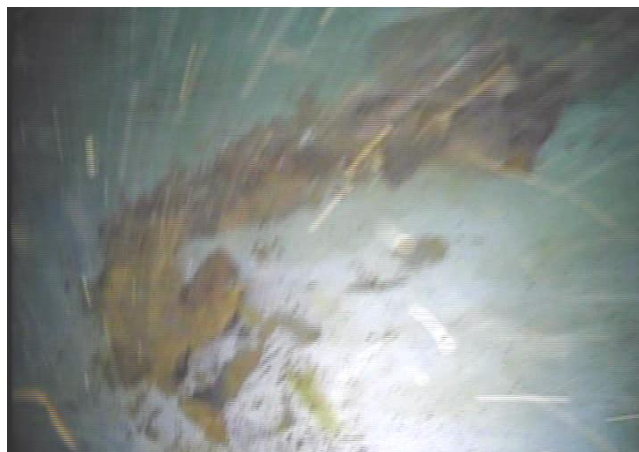
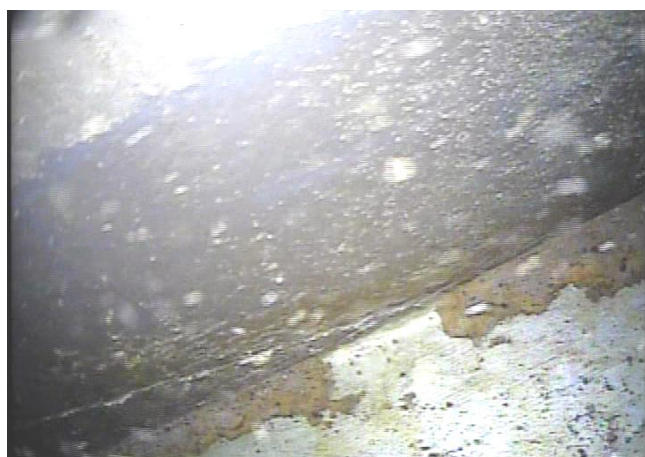
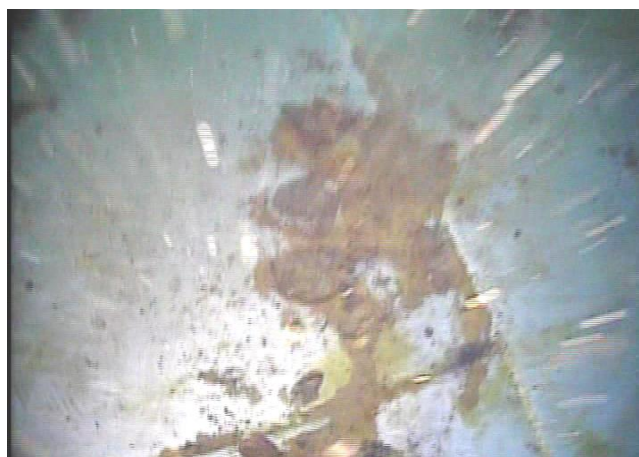
## Floor Condition

Summary: The floor was found in good condition with pitting, sediment staining and 2% concentrated cell corrosion & rust noduling noted.

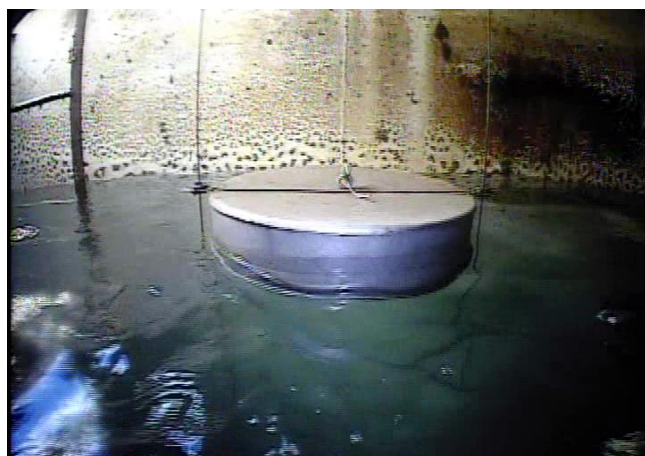
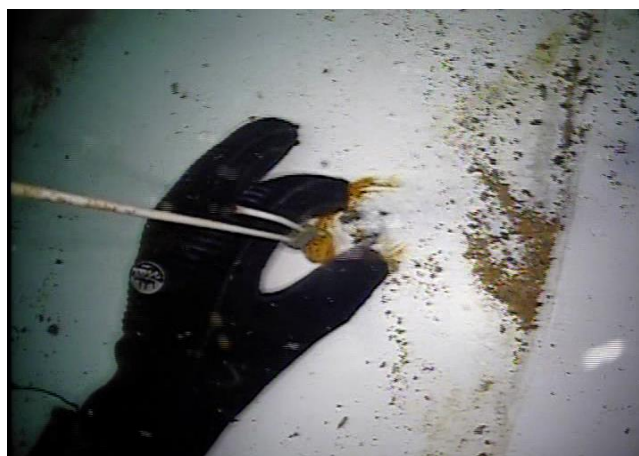
## Float Condition

Summary: The float was found in good condition but one of the guidewires was not attached and there was 50% concentrated cell corrosion & rust noduling noted on the hardware.
